Edward's Construction
A PARTNERSHIP
A General construction firm
Specializing in foundation repair
B-763218

1377 Camino Robles Way

Foundation evaluation

1. FOUNDATION INSPECTION EVALUATION

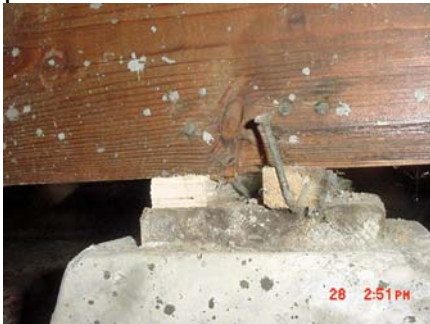
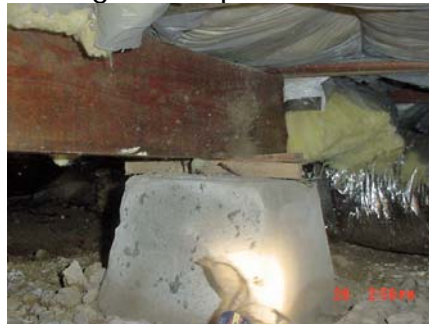
5. INTERIOR ISOLATED PIER POST SYSTEM

The interior isolated pier post assemblies support the main girders at the Interior of the structure. These assemblies are necessary to maintain a relatively firm and consistent elevation of the finish floor throughout the structure and stabilize the interior structural support. It appears that several of the interior isolated pier posts were installed without full bearing on the pier block.

I recommend the four pier post be adjusted with 4x4 Douglas fir and with a solid connection place between the beam and the post.

Cost estimate \$ 600.00

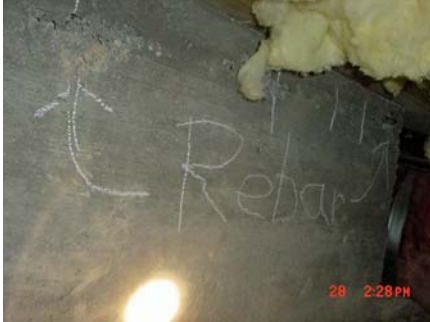
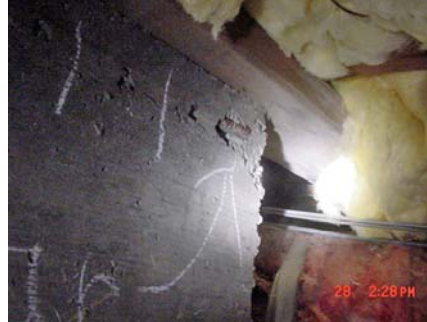
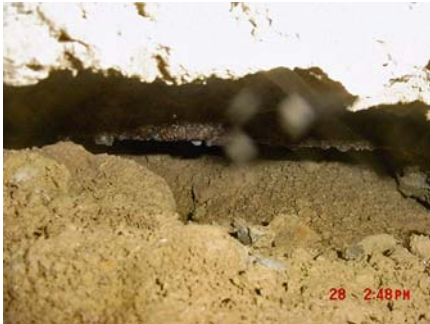
6. FRACTURES IN perimeter FOUNDATION

I observed approximately 2 vertical fractures in the foundation stem wall and grade beam. In addition, there are two areas where the reinforcement steel inside the concrete is showing and at the location where the sewer line goes underneath the foundation area.

Normally, in the concrete's alkaline environment, a passive layer forms over rebar preventing it from rusting. Chlorides or carbon dioxide can break down this protective layer; if water and oxygen are also present, the steel will rust. The rust can occupy up to 20 times as much volume as the original steel, creating tremendous forces that crack the concrete more so than is already present.

The area of the exposed steel at the stem wall should be clean epoxy over. The area of the exposed steel sticking out of the concrete should be cut off epoxy over.

Cost estimate \$ 950.00

In addition, resident or representative to note any significant movement or change in the foundation conditions should regularly monitor all fractures. Site drainage recommendations listed below should also be implemented to complete a more effective repair.
