WOOD DESTROYING PESTS AND ORGANISMS INSPECTION REPORT

BUILDING NO.	STREET, CITY, STATE, ZIP	Date of Inspection	No. of Pages
949	Steinway Avenue, Campbell CA 95008	2/16/2010	10

THRASHER TERMITE & PEST CONTROL, INC.

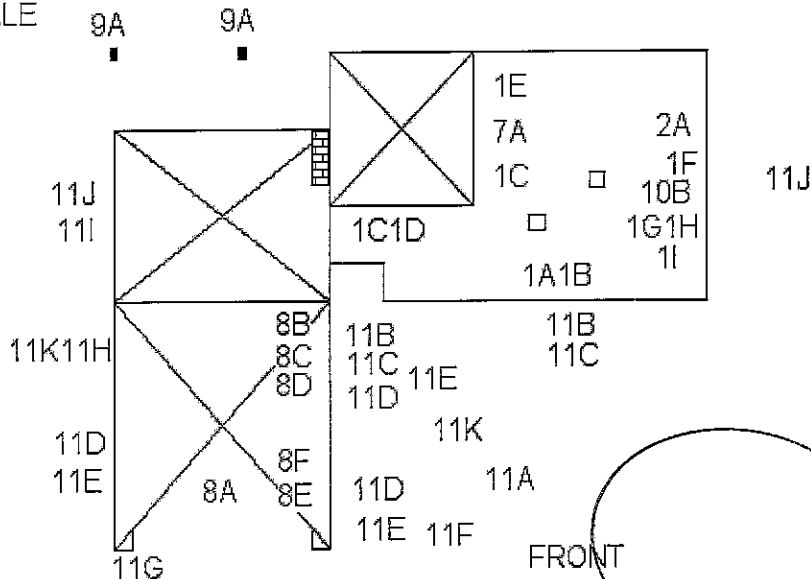
DIAGRAM NOT TO SCALE

ITEM 11I FINDING: Wood debris with evidence of subterranean termites was noted at the area indicated on the diagram.

RECOMMENDATION: Remove and dispose of the debris. Refer to item #1C which outlines a full subterranean termite treatment.
